Analysis of Differential Current Protection Trip Event for UHV Transmission Line

(High Voltage Laboratory: Liang, Wei-Chih; Lin, Ming-Jhou; Wang, Hung-Sheng; Power Supply Division: Chen, Ting-Jheng)

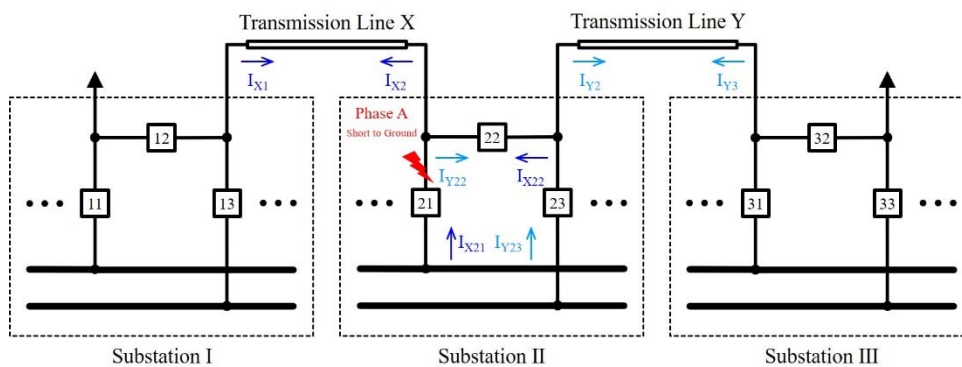
Figure 1 : Single-line diagram for 87L trip event

A differential current function (short as 87L) trip event occurred in a UHV transmission system and the line section immediately tripped. Figure 1 is a single-line

diagram of the trip. In this event, the 87L relays of transmission line X (87Lx) and transmission line Y (87Ly) operated and caused the circuit breakers (12 、 13 、 21 、 22 、 23 、 31 、 32) to trip. The substation maintenance staff found flashover traces and bird remains at the Disconnect Switchgear (DS) next to the circuit breaker 21 during inspection. The main cause of this trip event was judged that the birds stepped the grading ring above the Disconnect Switchgear (DS) by mistake and caused a phase A short circuit to the ground, and then caused 87Lx and 87Ly to trip circuit. However, the line to the ground short circuit occurs within the protection zone of 87Lx and outside the protection zone of 87Ly. No other but the transmission line X should be tripped. In this study, we aim to explore the reason of 87Ly operation in this accident.

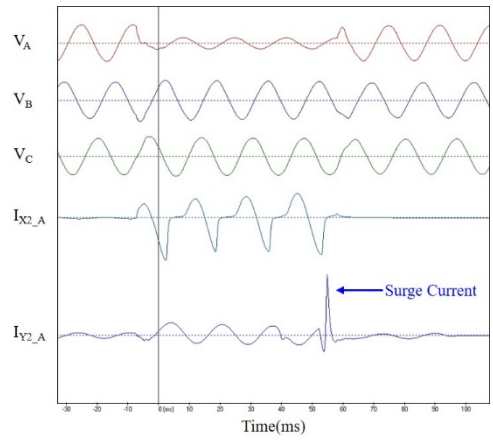
Figure 2 : oscilloscope event records at the substation II

Figure 2 shows oscilloscope event records at the substation II. The busbar phase A voltage V_A has a significant voltage drop and no other but the phase A current has a significant increase.

Therefore, it can be concluded that a ground fault occurred in phase A. Since I_{X2_A} waveform is not sine wave and has obvious distortion, it can be inferred that the current transformer (CT) is saturated. I_{Y2_A} has distortions and surge current at the end during short circuit.

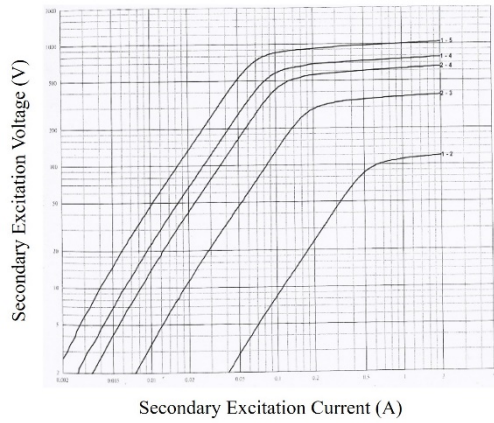
Figure 3 : Current Transformer (CT) excitation curves

event in the Real Time Digital Simulator (RTDS) model is the characteristic data of the current transformer (CT). Current ratio, secondary side impedance, load capacity, excitation characteristics, residual magnetism and other parameters are shown in Figure 3. The simulation results based on on-site oscilloscope and relay waveform records are shown in Figure 4, indicating that the short-circuit grounding event starts when the phase angle of A phase voltage is 135.6° . The circuit breakers at both ends of the transmission line X and Y tripped in sequence.

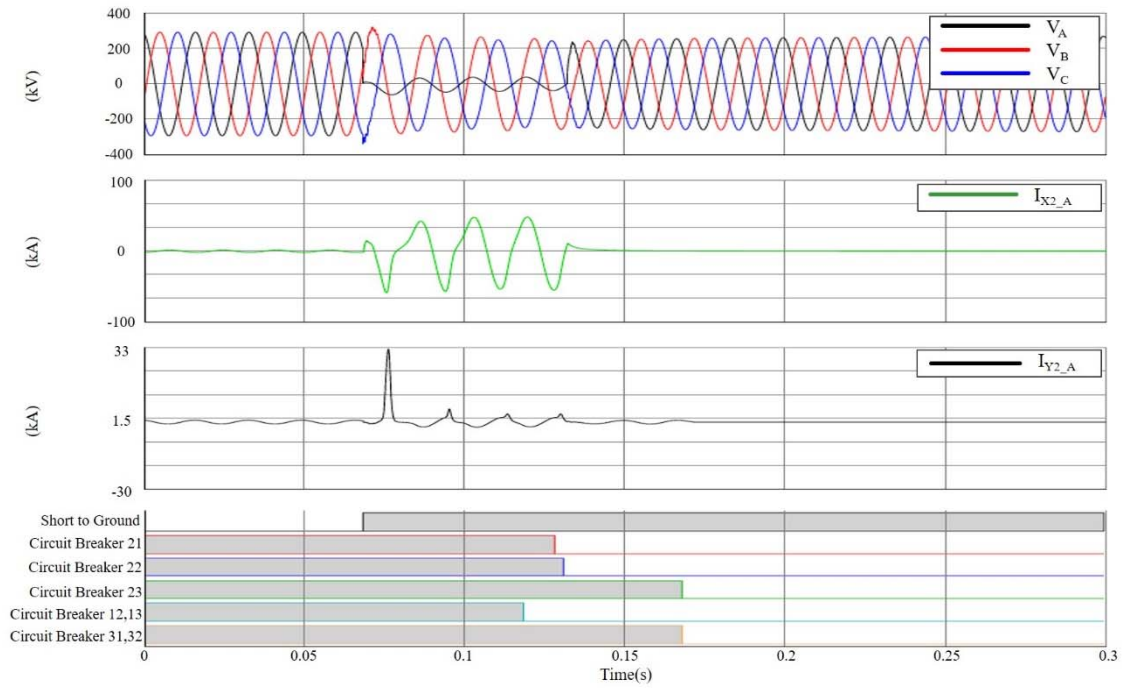
Figure 4 : RTDS simulation result of this event

This article analyzes a trip event of the differential current protection of a UHV transmission line. We use the waveform recorded by the on-site oscilloscope and protection relay to analyze the trip event caused by the saturation of the current transformer (CT) and the electromagnetic transient simulation is performed with Real Time Digital Simulation (RTDS). To verify the consistency of our analysis, the simulation results have been compared with the event records. It not only shows a complete explanation of tripping root cause, but also provides important reference information for the planning, design and maintenance of UHV transmission line differential protection in the future.
