## Case Study of Solar Photovoltaic System Cable Connectors Failures

Chemical Testing Section: Yang, Cheng-Han; Chan, Sheng-Kai; Chang, Chia-Hao  
 Taipower Renewable Energy Department: Ye, Zun-Dong; Luo, Ming-Lin

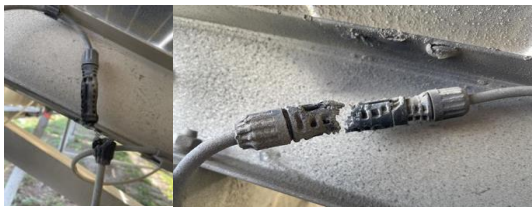
Fig 3 Appearance of burned-out Connectors

Since January 2023, a significant number of failures have occurred in the photovoltaic module connectors at a domestic solar power station, resulting in nearly 3,100 series strings failing (statistics until January 2024). Most failures have occurred at the junctions where the positive and negative poles of the series strings connect to the DC lines, causing severe loss

in electricity generation. This study analyzes five sets of connectors used in the station to clarify the reasons for these failures and improve the operational reliability of the solar power station. The on-site burn damage appearance and samples of the five sets of connectors are shown in Fig. 3 and Fig.4, respectively.

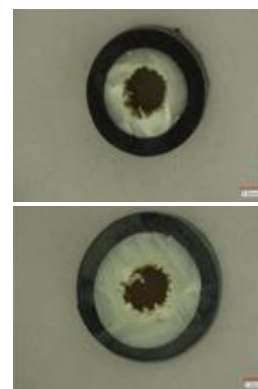
Fig 6 Cross-sectional diagram of the conductor connections at both sides

After measuring the dimensions of the conductors at both sides of the connector, it was found that while the conductor (stranded copper wires) diameters were the same, there was a significant difference in the outer diameter of the conductor insulation. The outer diameter of the insulation at the socket side was noticeably larger than that at the plug side. This dimensional difference is hypothesized to be the primary reason for the different gaps observed on both sides, as shown in Fig. 6.

(Up: Plug conductor  $\phi 6.2$  mm; Down: Socket conductor  $\phi 7.5$  mm)

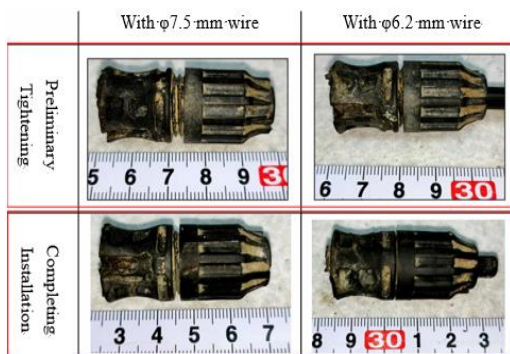
Source: Pictured by TPRI  
 Fig 7 Comparison of gaps between preliminary tightening and complete installation

Following the above steps, we conducted a practical simulation of the connector locking process. When only the handheld wrench was used for preliminary tightening, the observed gap distance matched that found in the connectors used on-site. Subsequently, applying the recommended torque using a torque wrench (4 N-m suggested for AWG #12 wire diameter) visibly reduced the gap distance, as shown in Fig. 7. Therefore, it was deduced that the installer only performed preliminary tightening without completing the installation.

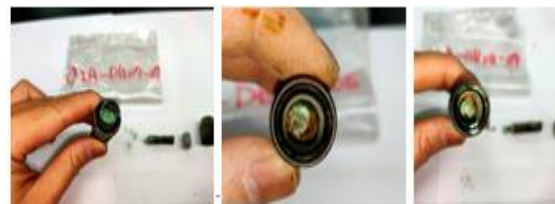
Source: Pictured by TPRI  
 Fig 9 Corrosion products and oxides on the connectors

An incomplete connector assembly due to inadequate tightening could not prevent moisture and dust from entering (Fig. 8), leading to the formation of corrosion products and oxides (Fig. 9). This incomplete assembly contributed to subsequent overheating and burning at the connector junctions.

Based on the results of SEM-EDS analysis, it is inferred that the bright green areas inside the junction are corrosion products of copper alloys formed due to humid and salty environments (such as basic copper carbonate (Patina) and copper chloride). The black areas inside the junction are copper oxides formed due to high-temperature oxidation. Both are consequences of inadequate connector assembly.
