Research On Maintenance Strategies For Cracking Steam Turbine Blades In Thermal Power Plants

(Energy Research Laboratory : Wu, Hsien-Cheng; Chen, Ruey-Chyi; Chung, Chen-Chou; Liao, Chia-Chi; Huang, Tai-Yuan; Lo, Chi-Hao; Lin, Jyuan-Han; Liu, Da-Ming; Duan, Shiang-Ren)

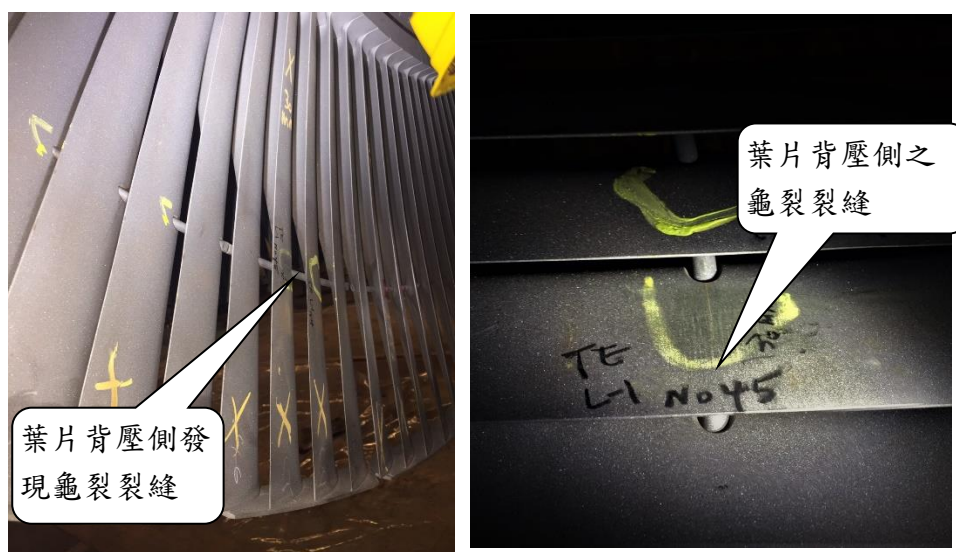
During the major overhaul of the thermal power plant, cracks were found near the lacing wire of the suction side of the low-pressure steam turbine blades. Figure 1 shows the crack locations of the turbine blades. Due to the lack of spare blades for the low-pressure turbine from the power plant and OEM, it would be time-consuming and costly to repair the blade cracks by stopping

Fig. 1 Photo of the suction side of the low-pressure turbine blades (left) and the location of its crack(right).

the units. Therefore, the power plant entrusts Taiwan Power Research Institute(TPRI) to support the maintenance and repair strategies for steam turbine blade cracks. The main content of the strategies is to study the method and manufacturing process of welding-repaired cracked blades on the low-pressure turbine rotor without disassembling the cracked blades.

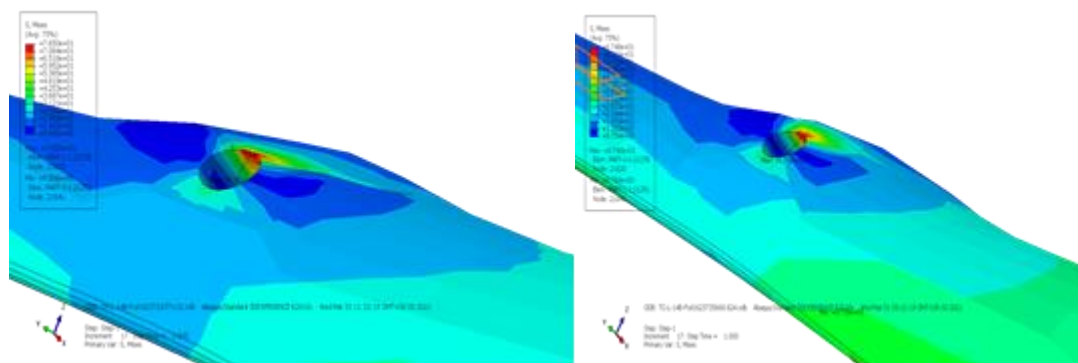
the finite element method (FEM) software for structural mechanics analysis. The analysis results showed that the location where blade crack initiation is where stress is concentrated, and the centrifugal stress location is quite close to the modal stress location. To improve the stress concentration, TPRI increases the thickness of the stress concentration point and verifies it through structural mechanics simulation. The analysis results show that this modification can reduce concentrated stress. Figure 2 shows the stress distribution diagram of blades before improvement (left) and after improvement (right).

Fig. 2 Blade stress distribution diagram before improvement(left) and after improvement(right).

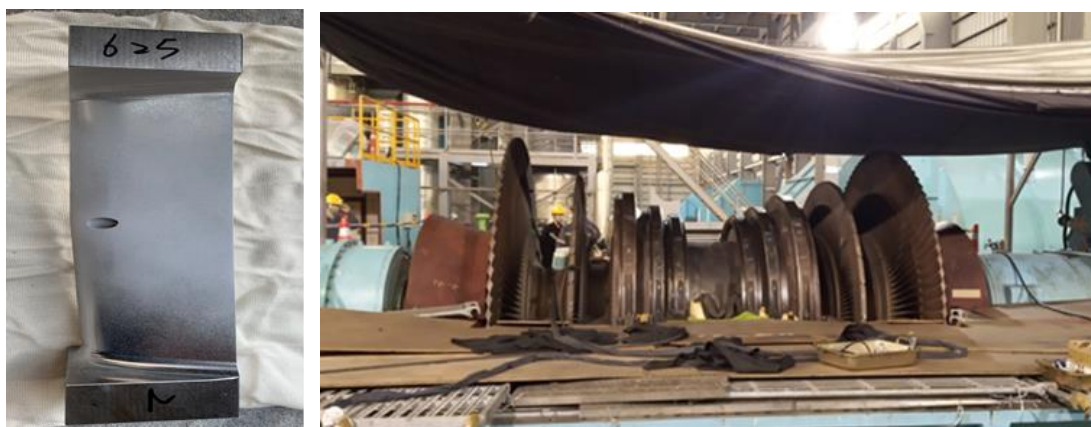
Fig. 3 Photo of the welded test specimen (left) and the blades to be repaired on the steam turbine rotor (right).

mechanical properties are confirmed to be similar to or better than those of the blade material. After verification, the cracked blades on the steam turbine rotor will be ground, grooved, welded, non-destructive tested, and stress-relieved heat treated. Finally, confirm the dimension of the repaired blade and compare it with the original dimension. Fig. 3 shows a photo of the welded test specimen (left) and the blades to be repaired on the steam turbine rotor

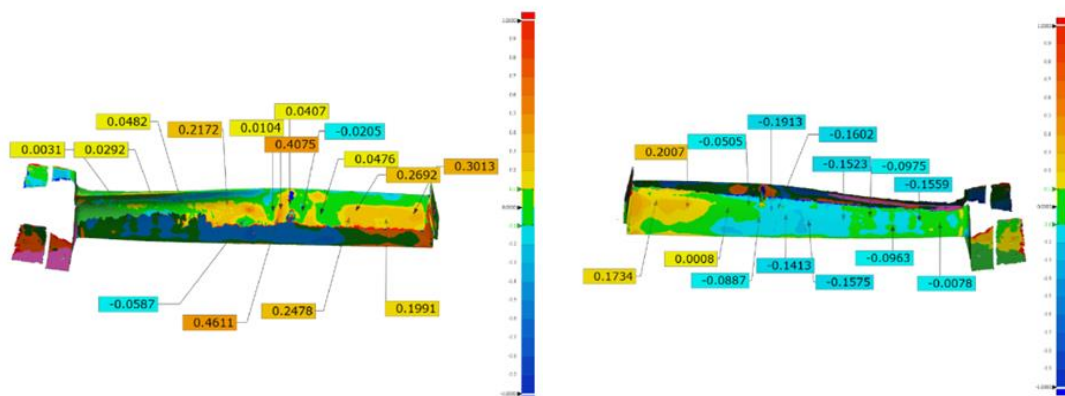
(right). Fig. 4 indicates reverse scanning and modeling of the blade after heat treatment.

Fig. 4 Reverse scanning and modeling of the blade after heat treatment.
