# Case Study of Dissolved Hydrogen Growth in Power Transformer Oil

( Oil & Coal Section: Lee An-Ping, Lee Li-Chi, Chang Ya-Ying )

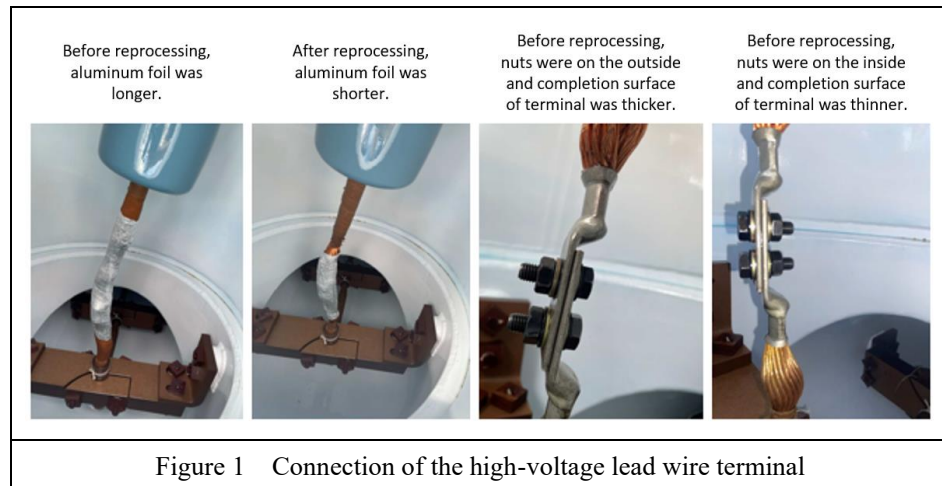
Figure 1 Connection of the high-voltage lead wire terminal

It may cause the local strength of the electric field to be too large, resulting in corona in oil and continuous generation of hydrogen. Taking the connection of the high-voltage lead wire terminal of the transformer in Figure 1 as an example. The terminal was covered with aluminum foil longer than the design value, and the nuts were locked on the outside of the terminal during construction. Those resulted in more parallel parts of the bolt protruding from the terminal. The completion

surface was thicker, so corona occurred and the value of hydrogen grew at a rate of more than 30 ppmv per month. The

phenomenon of hydrogen growth stopped after the connection of the terminal and bandaging method were improved.

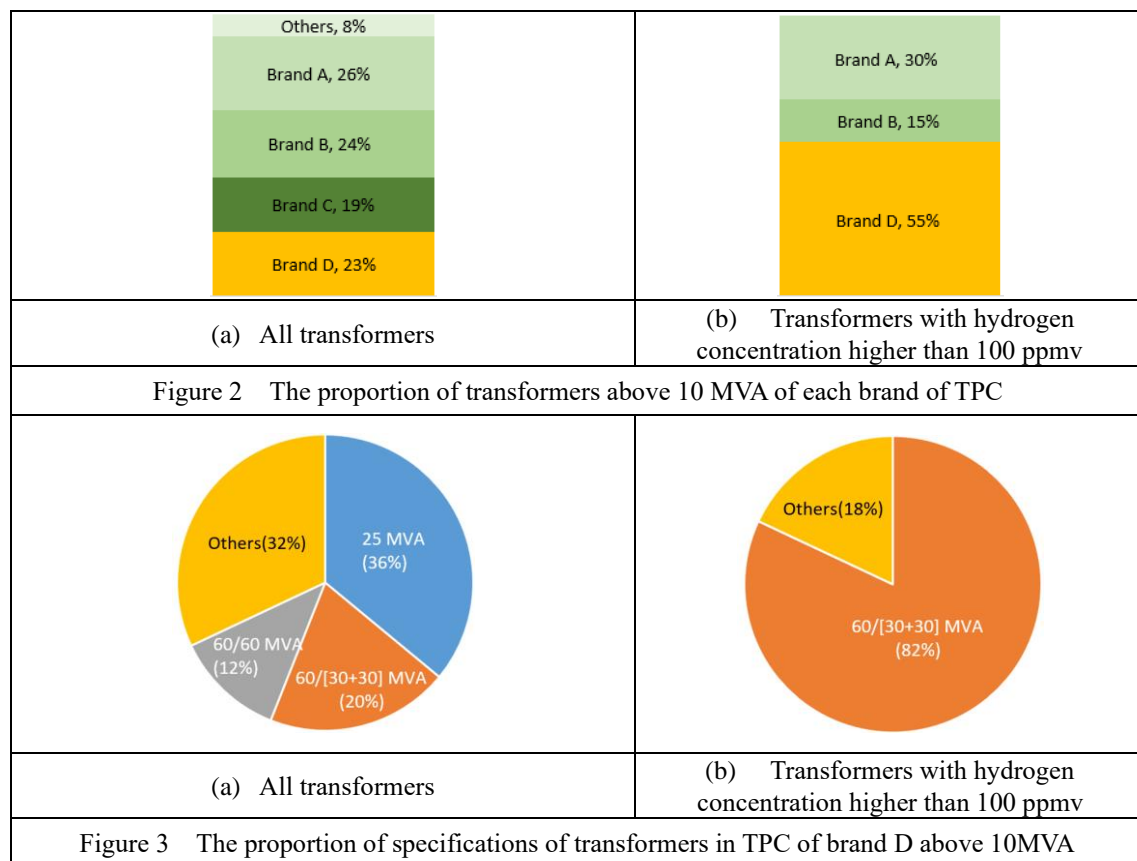
that although the transformer of brand D only accounts for 23% of total transformers, the proportion of transformers of brand D with hydrogen concentration greater than 100 ppmv is as high as 55% (Figure 2). By further analysis, it can be found that transformer of 60/[30+30] MVA accounts for only 20% of all transformers of brand D, but among those

with hydrogen concentration of greater than 100ppmv, this type accounts for up to 82% (Figure 3). Compared with the design or materials of other manufacturers, transformers of brand D have a significantly higher probability of hydrogen growth, and the type of 60/[30+30] MVA is the most prominent.
